Repair and Strengthening of Penstock Pipe/Tunnel System of a Hydroelectric Power Plant

Turkey
2012

PROJECT BRIEF

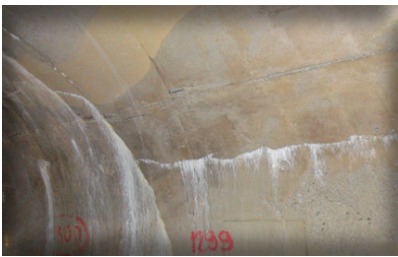
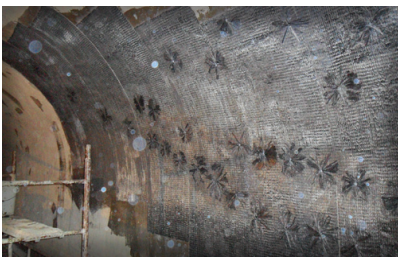
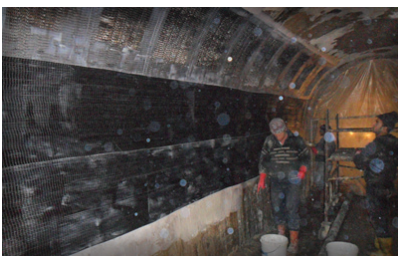
A run-of-the-river hydroelectric power plant was built in 2011 in Trabzon –a city on the Black Sea coast of north-eastern Turkey. The penstock pipe/tunnel system that carries the water from the intake to the turbine is normally under significant water pressure ranging from a couple of bars to 37 bars. The reinforced concrete tunnel of this system (2.3km length) -with a cross section area of around 9m² - developed significant cracks along the hoop and longitudinal directions due to the pressures ranging between 4-15 bars. The concrete lining has also been degraded in some segments and Tekstar – the certified applicator of Tyfo® Fibrwrap® Systems in Turkey- was contacted to find a repair and strengthening solution.

Following detailed design stages and Fyfe's recommendations, the structural cracks were first repaired by epoxy resins injections and cavities between tunnel lining and rock mass were stabilized by polyurethane / silicate resins and then Tyfo® SCH-41 Composite System was used to wrap the inside of the cracked tunnel segments. The Tyfo® Composite System served as an external reinforcement and provided resistance in both hoop & longitudinal direction preventing future cracks. A couple of months after the application a proof test started where a water pressure at 37 bars was sustained at the turbine for 4 months test period. The Tyfo® application made the tunnel fully functional. Following the proof test there was also a walk-through check in the tunnel and no deterioration was observed.
